## 2009 FORD F-150 CAB REPAIRS

**Scope:** Determine proper holding, measuring and repair methods using Car-O-Liner Equipment to facilitate OEM factory process and procedures for F-150 Cab Repairs. On-Frame/ Off- Frame repairs were investigated. Cab repairability off the frame of the vehicle was determined to be minimal and possibly less than 10-15% of total repairs so on-frame techniques were also investigated.

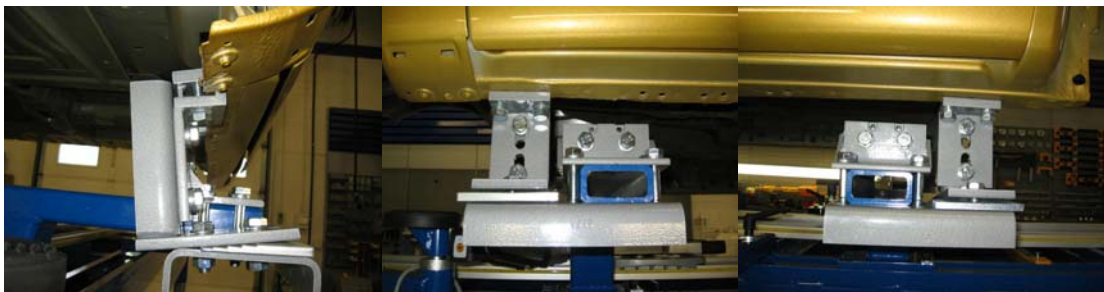
**2.** Upon first inspection it was determined that in fact COL has clamps already in the field should the 'cab only' need securing to the bench while disconnected from the frame, this can be performed using B223 Clamp with a B246 Wedge to adjust angle of the connection flange. Cab was secured and measured to determine tolerances for creating a data sheet.

**CLAMPING EXAMPLE (SIDE VIEW, FRONT CLAMP, REAR CLAMP)**

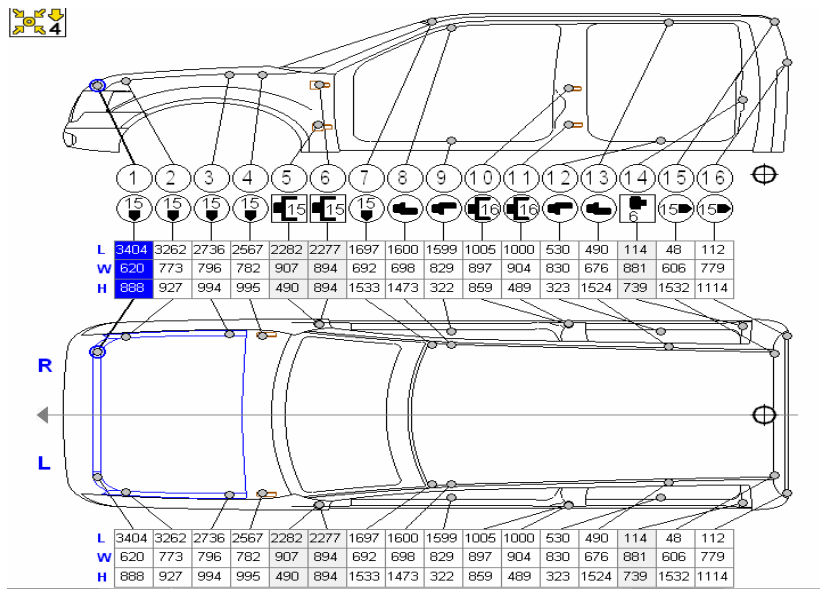
3. When testing to determine tolerances was complete, COL created both lower and upperbody datasheets for the cab only for use with Car-O-Liner Car-O-Tronic Measuring Systems. UpperBody dimensioning will require use of the included High Measuring Pointer (HMP).

**EXAMPLE OF UPPER BODY DATA MEASUREMENTS**

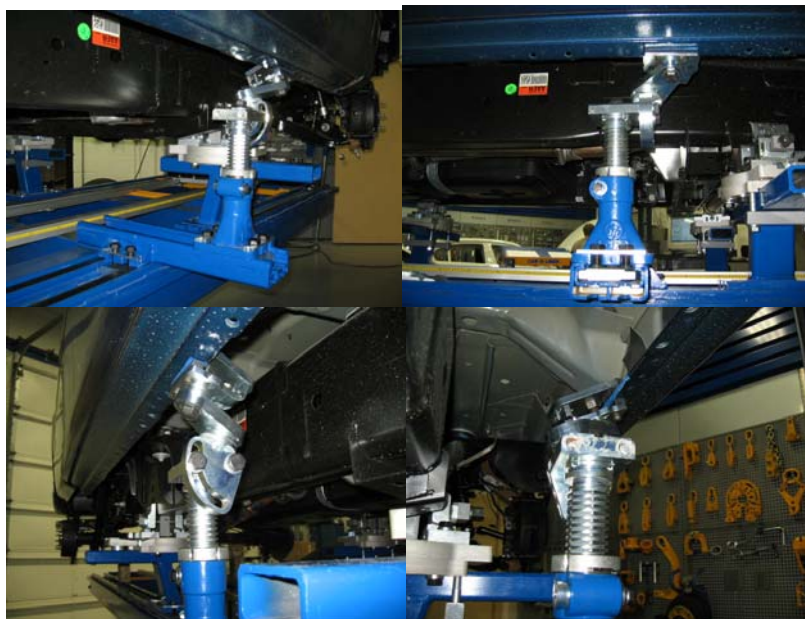
4. Due to most repairs being performed on the vehicle it was determined that repair options should be designed for both light to heavy pulling and repair situations. Using EVO while the vehicle is mounted for frame correction or independently mounted several areas of holding are available using existing EVO 1-2 systems.

**Universal Clamping to Pinchweld Area Using EVO**

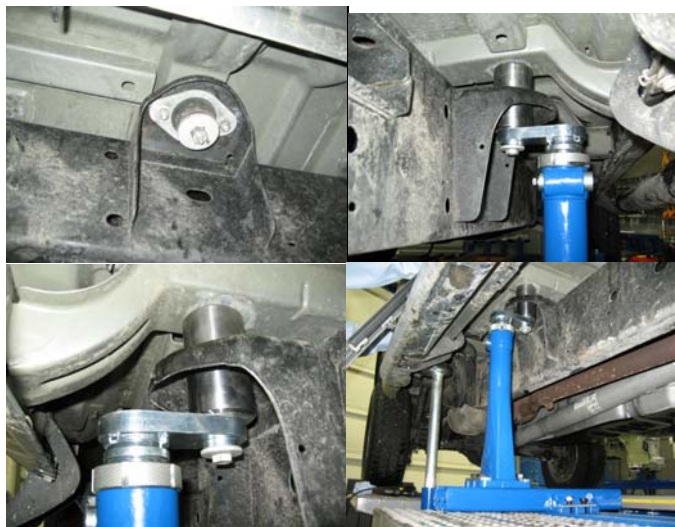
- C. While being supported by the Pillar Jacks, remove the Cab Biscuits (Bushings from frame connection to cab)
- D. Install EVO Towers in place as shown in the Vision X3 and Vision EVO dialog for each individual holding point on the cab only data sheet. An accessory package of Steel Bushing and replacement bolts for holding the cab will be necessary. (UNDER FINAL STAGE OF DEVELOPMENT) The steel bushing will slide between frame mounting and bolt goes through the EVO Holder and bushing while threading into the cab mount cage nut.

**NOTE: MOUNT AREA AND BUSHING PLACEMENT**

**NOTE:** This should be performed at all mount locations depending on extent of the cab damage. In some instances the Accessory Bushing may not be required at the core support.

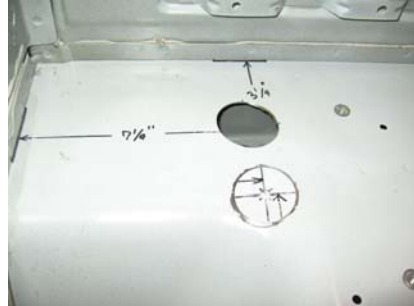
**ADDITIONAL FINDINGS:** In some instances the 'Caged Nut' in the cab may spin and require securing in order to complete the repair processes. Sample photo below shows procedure to access the nut area from the top by measuring and drilling a hole from inside the cab for access.

**ACCESS HOLE FOR CAGE NUT**
